## The Pine City Civic Center Pine City, MN FACILITY EVALUATION

HTG Project #131171 in conjunction with  
Stevens Engineers in Hudson, WI and  
Gausman & Moore in St. Paul, MN

HTG Architects  
Eden Prairie, MN  
November 2013

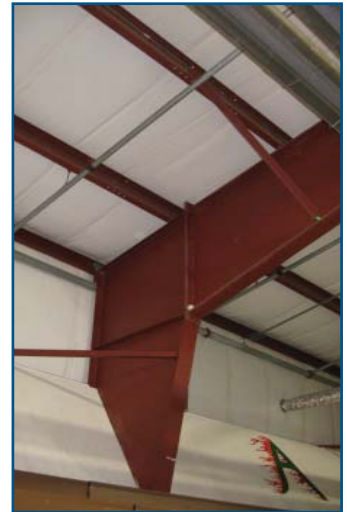
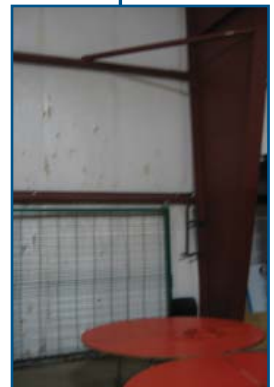
The exterior wall finish on this arena is sheets of factory painted galvanized metal panels. The wall panels are secured to the factory primed steel framework by screws with rubber grommets. The screws however transmit exterior cold and hot temperatures through their shanks into the frame work of the arena building. This type of temperature transfer causes moisture to condense on the screw shanks within the insulation causing the insulation to become wet. Over time wet insulation losses its insulation value and triggers the beginning of oxidation in the steel walls structure and the structural steel frames. At a certain point, wet batt insulation will start to lose its thermal capacity causing the refrigeration and dehumidification systems to work harder to maintain the ice sheet. When both of those systems start to work harder to maintain the atmospheres within the building, utility bills start to increase. We did not probe into the insulation with any electronic instruments for reading the moisture content, but we did simply insert our hands into some of the holes allowing us to feel the temp difference from the back side of the exterior metal paneling and the inside face of the steel structure. Moisture was felt in some places.

Currently when the refrigeration system sensor(s) signal the compressors to stop, the temperature in this type of building will soon start to rise. When batt insulation starts to become saturated, the time line for the building to start to warm up will become shorter and shorter. Less time to heat up will cause the refrigeration system to cycle more often increasing the operational costs.

Failure in this type of wall system can also be caused by other factors known as “catastrophic failure” of the protective metal skin. This can be seen in the south wall just west of the existing gas meter. (Refer to photo “A and B”). A concave fracture can also be seen, most likely caused by heavy snow cascading off the roof and stacking up against the wall. Further evidence of the theory is that the gas meter has had a shed roof added over it to protect it from the same snow. Referring to photo “C”, one can start to see where the concaving effect of the snow has also started to create an opening at the base of the wall panel which allows moisture to seep in at the bottom of the wall. There are also horizontal cracks starting to show up in the metal siding at the screw locations in this concaved area. These cracks will start to show rust and deteriorate into larger holes that will subject the batt insulation to further moisture infiltration causing further loss in its insulation value.

We recommend the existing batt insulation system be removed in its entirety. Then an inspection of the metal wall panels inside face should be made for damage and rust. Replace those metal wall panels that have been badly damaged, remove minor rust from the remaining panels. Then recommend the panels with damage be sealed at the repaired panel areas per manufactures recommendations.

Consider filling the empty wall cavity with a minimum R value between R18 and R26 of a closed cell foamed insulation application. Foam insulation is impervious to water and should be checked to make sure the type used is “UV” resistant. The walls will still have no thermal storage capacity but will efficiently stop the thermal transfer of heat, moisture, and UV rays at the face of the outside wall. The interior surface of the insulated wall will need to be covered to protect it from forcible damage read further below.

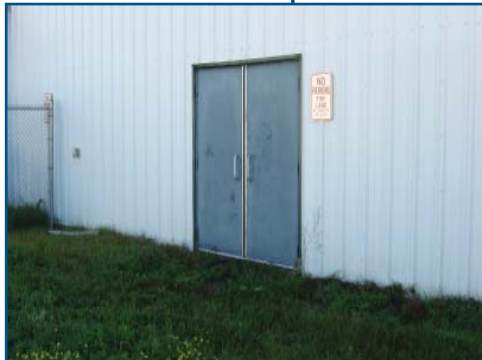
Although not a contributing factor to the operations of the arena during our observation tours it came to our attention there are two sets of exit doors from the arena that open out onto grassed landings. The State Building Code requires all exit doors opening to the out side shall have concert landings supported by frost footing. There's no code requirement for sidewalks leading from the landing. Concrete landings are easier to maintain in the winter to insure that the exit doors will not be blocked by snow and Ice and that the landing do not heave from frost stopping the doors from opening in an emergency. We have provided a typical section detail through a landings construction. A pair of 3' exist doors require a landing approximately 8' x 5'.

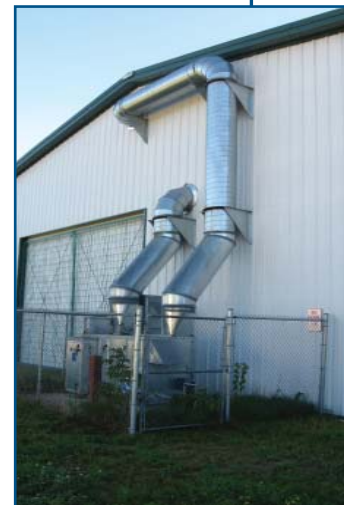
The arenas existing refrigeration system was explained as a modified system that is normally used to run a supermarkets freezers. Refer to Stevens Engineers' Refrigeration Section of this report. We understand it is a modified used piece of equipment when purchased with four compressors, only one of them new with a rating of 70-80 tons. The flow rates of the pumps are good, the units capacity is not sufficient however to maintain a longer season. The group confirmed this by saying they have tried several times to make ice in September only to get frost but that was it. A preliminary size of 90 tons was discussed.

Comments were made regarding the size of the current refrigeration room and it will most likely be large enough. However, the type of refrigerate selected to be used in any new or renovated refrigeration system may result in modification needed to the existing refrigeration rooms construction. As an example, should an ammonia base refrigerate be selected, the room will need to be renovated in the following manner to comply with current Codes:

1. The room's construction type will need to be confirmed as a 1 HR system and any modification needed will have to be included in any remodeling.
2. The door leading to the refrigeration room can not open onto any part of the arena unless it is part of a designed air lock vestibule. We recommend a new door be added that opens directly to the exterior and the current door be blocked up
3. A new isolated ventilation and alarm system will need to be designed and installed in the refrigeration room.
4. An eye wash sink will need to be added to the room improvements as well.

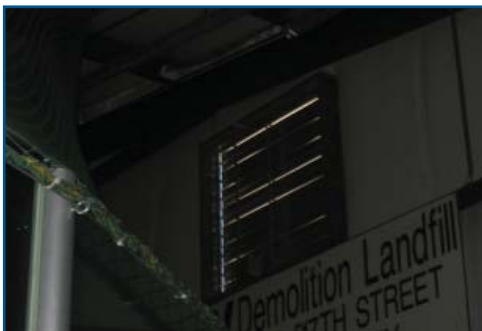
**Envelope Penetrations:** A tight building enclosure is a necessity for proper early and late extended season operation. It is critical that all penetrations be sealed. Even small openings can introduce moisture which can damage building materials and increase the energy use of the refrigeration system. There are two areas of concern noticed during our visual observation.

One area is the motorized outdoor air intake dampers. When standing in the arena, there were visible gaps in the damper blades even though the dampers were indexed to the fully closed position, and this is typical of both dampers. We recommend that these louvers be replaced with insulated dampers with gasket blade and edge seals so that the gaps are eliminated. The damper operators and linkage should be adjusted to make sure that the dampers are able to fully close. This condition may also exist at the exhaust fan discharge dampers, but this was not readily observable. If it does, the comment above applies at this location as well.

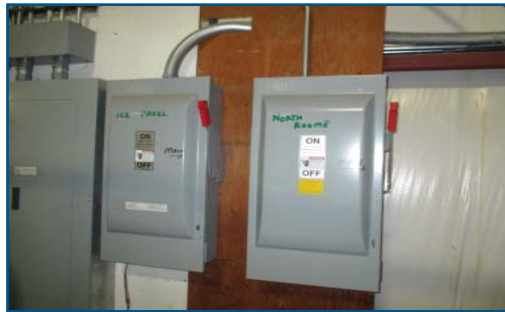
The electrical distribution system is an existing 480/277 volt, three phase 800 amp service which is served from a 300kVA utility owned transformer. This transformer serves a number of disconnect switches which follow the National Electrical Code's 6-disconnect rule.

The disconnect switches feed lighting and motor/equipment panelboards as well as transformers to transform the voltage to 208/120 volts which feed smaller motors and receptacle loads. The highest demand load (kW) recorded by the utility company (East Central Energy) in the previous 3 years is 111.2 kW. This equates to approximately 170 amps at a 0.8 power factor which is considerably less than the capacity of the distribution system and the utility transformer serving the distribution system. The electric distribution system appears to have capacity to upgrade the dehumidification and refrigeration system if it is required to extend play earlier and later in the season.

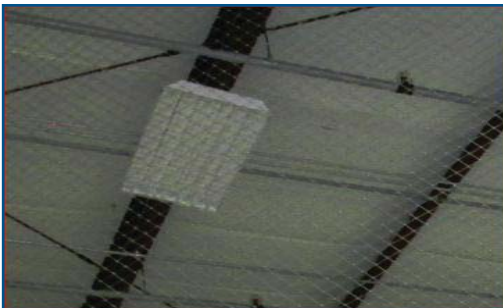
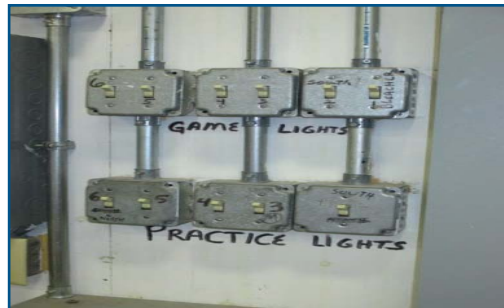
The arena lighting system consists of 6 lamp T-8 high-bay fixtures. This style of light fixture lends itself well to the task of lighting an ice arena, in light output, illumination of the rink, and in controllability as the fixture requires multiple ballasts to power the light fixture and allows additional switching capability. In addition, no considerable start up time is required to bring the light fixtures to full output. The existing rink lighting is switched manually with multiple zones to provide high and low light levels as needed.

Additional lighting control could be added to ensure lights are automatically turned off, although a facility manager currently turns the lights off after the facility is done being used for the day.

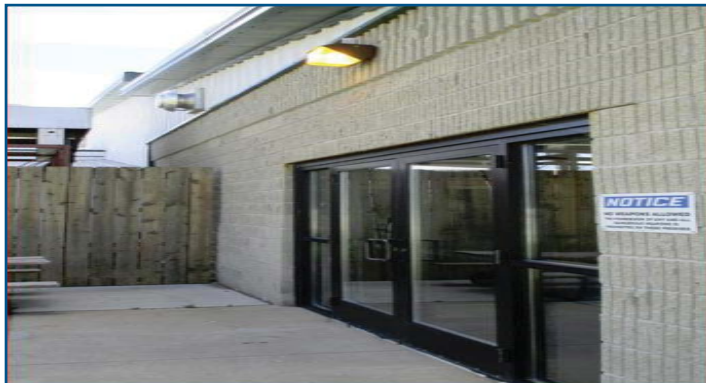
Exterior lighting, which is High Intensity Discharge (HID) may be exchanged for LED style fixtures which provide a better light while also reducing the energy used. LED lighting fixtures also have a long life of over 70,000 hours decreasing the maintenance costs of the exterior lighting.
